Apex Cleaning Instructions

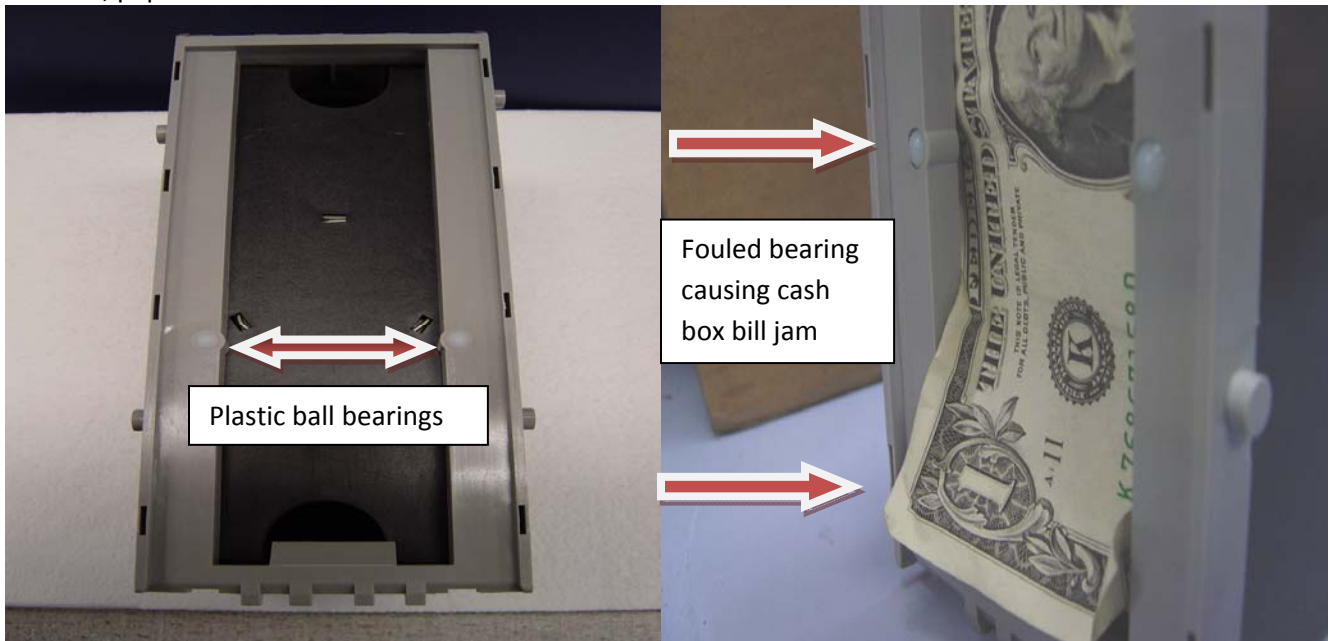
If you have a cash box, first locate the two white plastic ball bearings. They are located on the plastic frame that is inserted into the bill validator. There is one bearing on each side of the plastic frame. The plastic ball bearings can get fouled with lint, paper dust and dirt.

This can cause the bearings to not make full contact with the bill or completely stop it from moving. This condition will create bill jams, possibly leaving the bottom of bill slightly outside of the cash box. Dampen a lint free cloth with water (only enough water to pick up dust) and run the cloth up and down over the bearings until all debris is cleared.

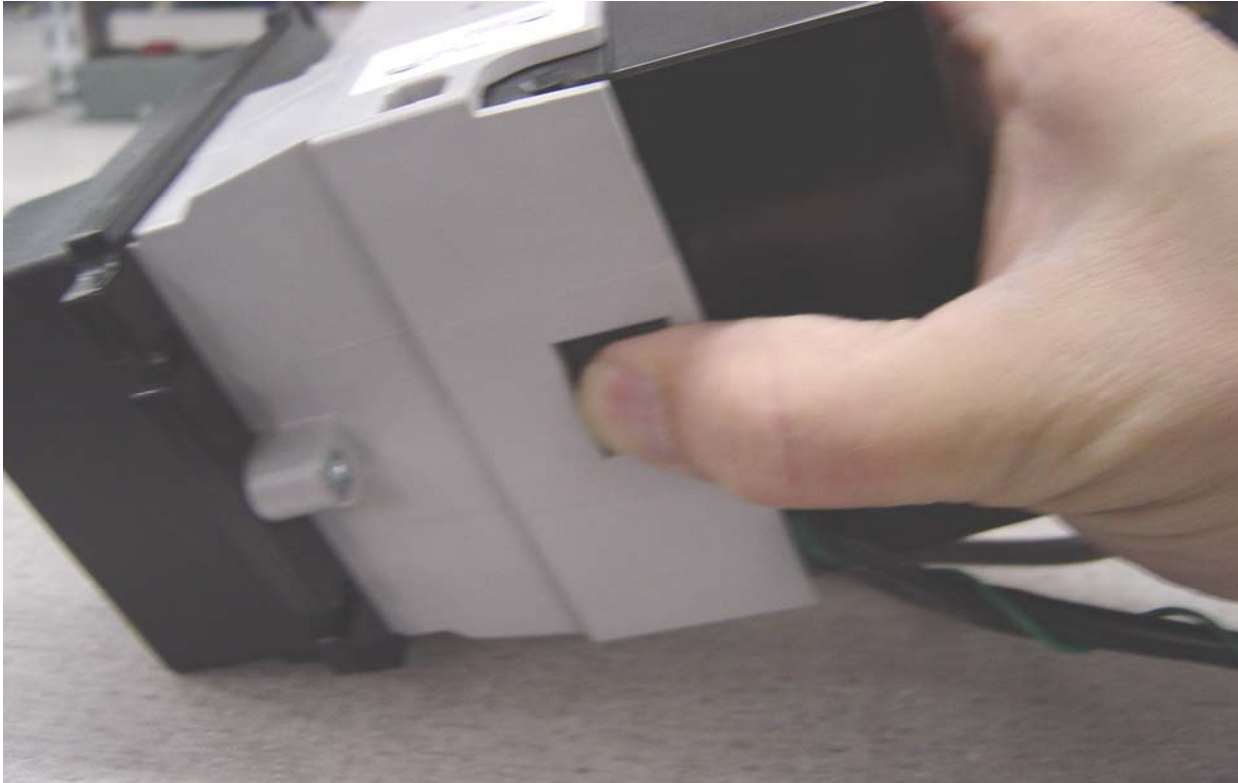
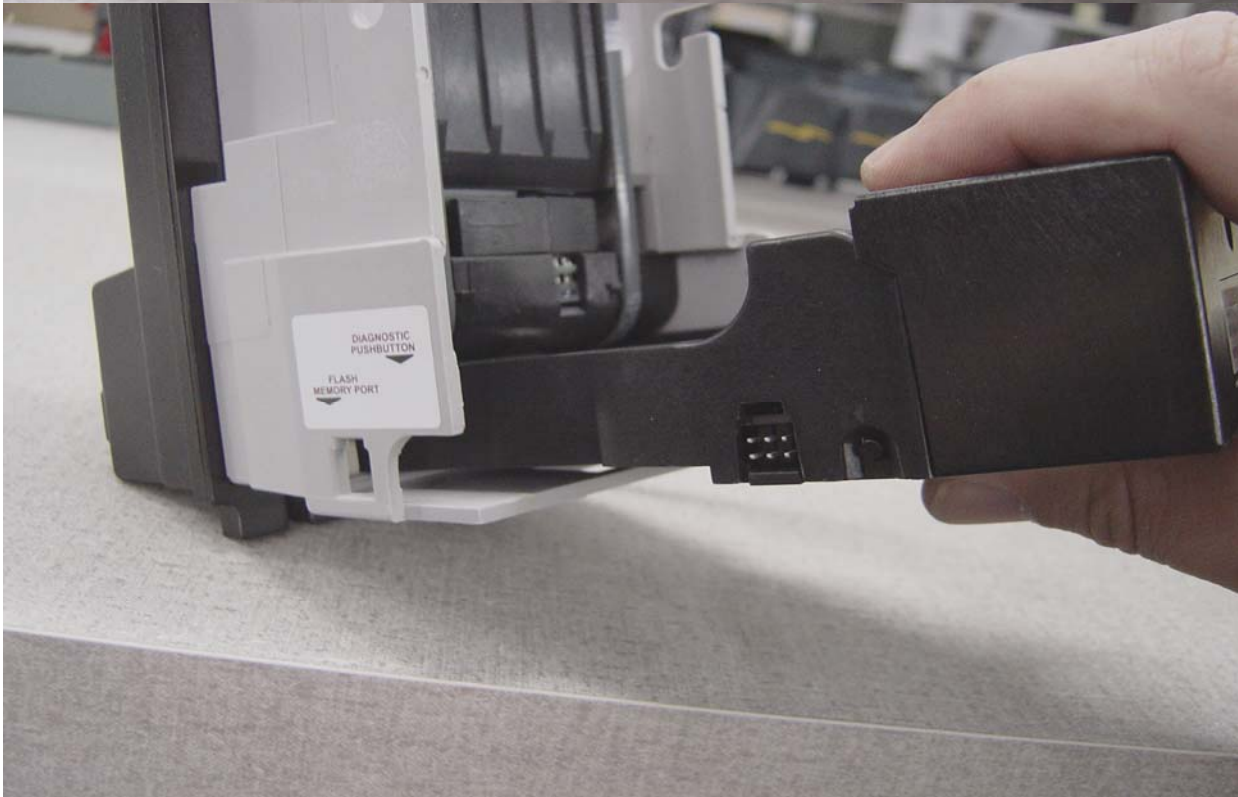
No tools are required to pull the bill path plate out. There is a recessed latch that must be pushed in to release the plate. While pushing the latch in with your thumb, pull the plate straight back out of the main frame of the bill acceptor.

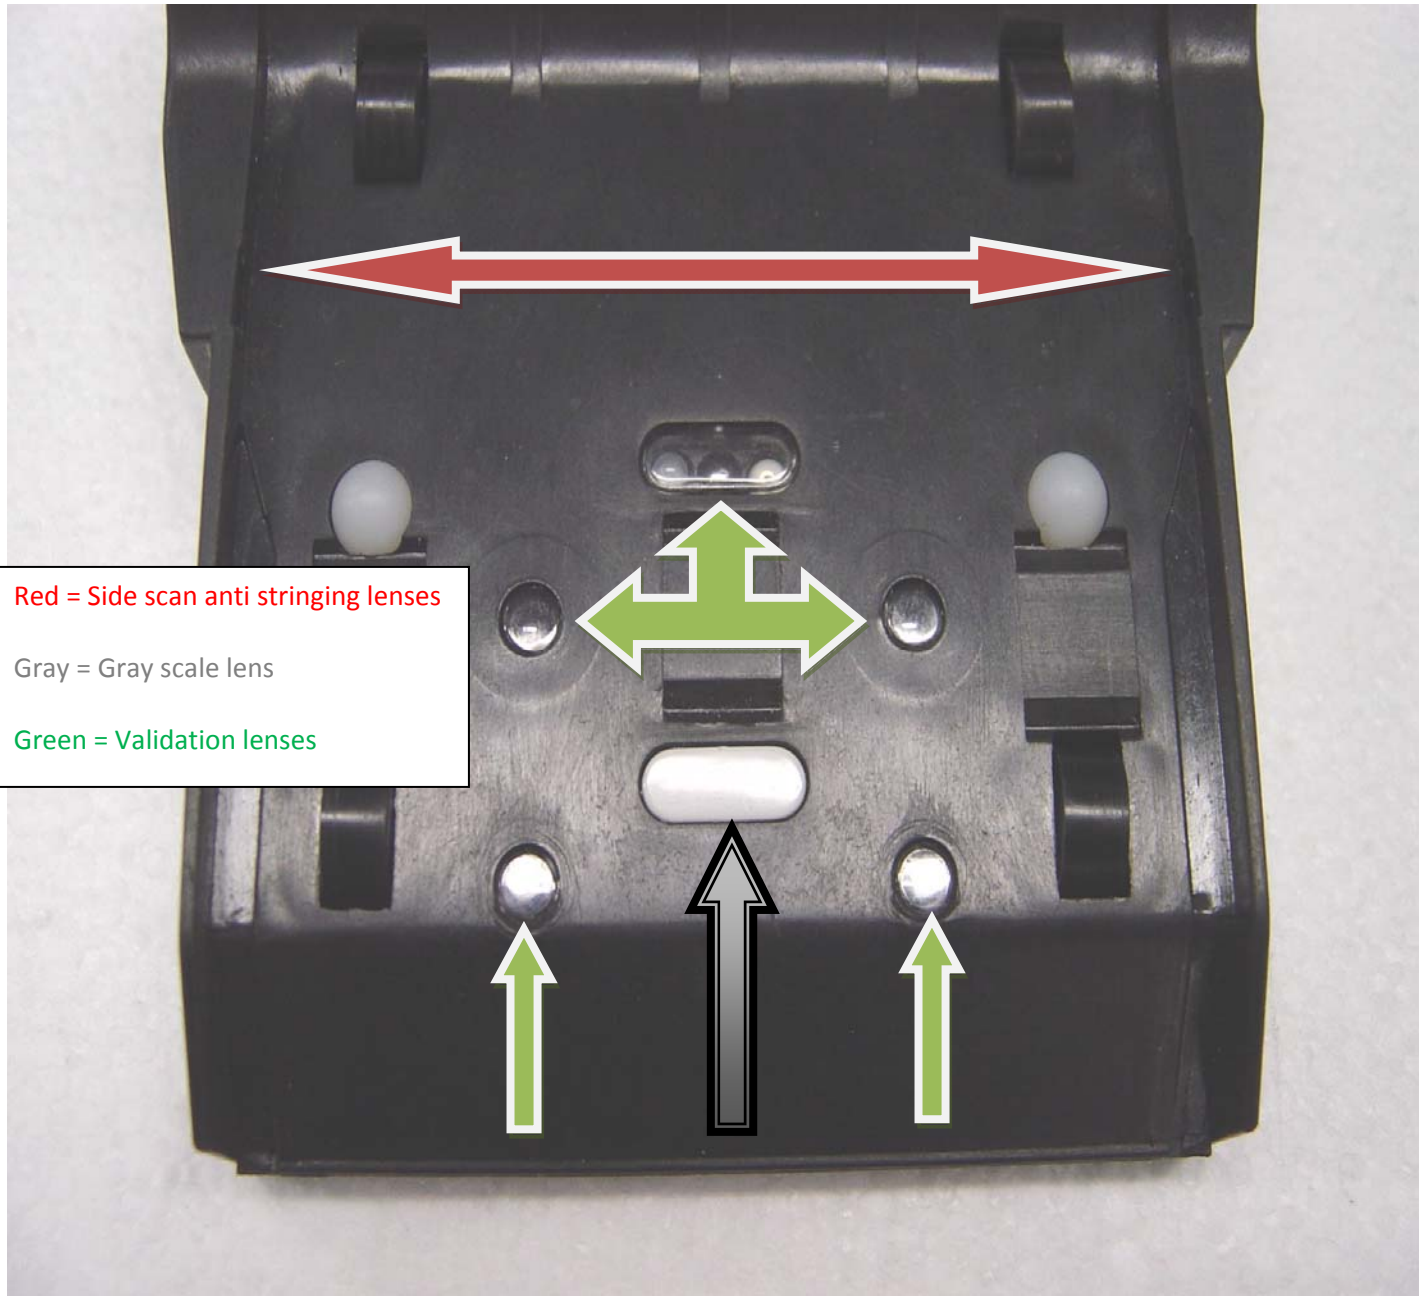
Once the plate is out you will have full access to all the validation and side scan anti stringing lenses.

Inspect the plate for dust, dirt, smoke and debris. There are four round lenses and two oval lenses in the plate that must be cleaned. Dampen a lint free cloth with water, only enough water to pick up dust and run the cloth over all lenses and rollers until clean.

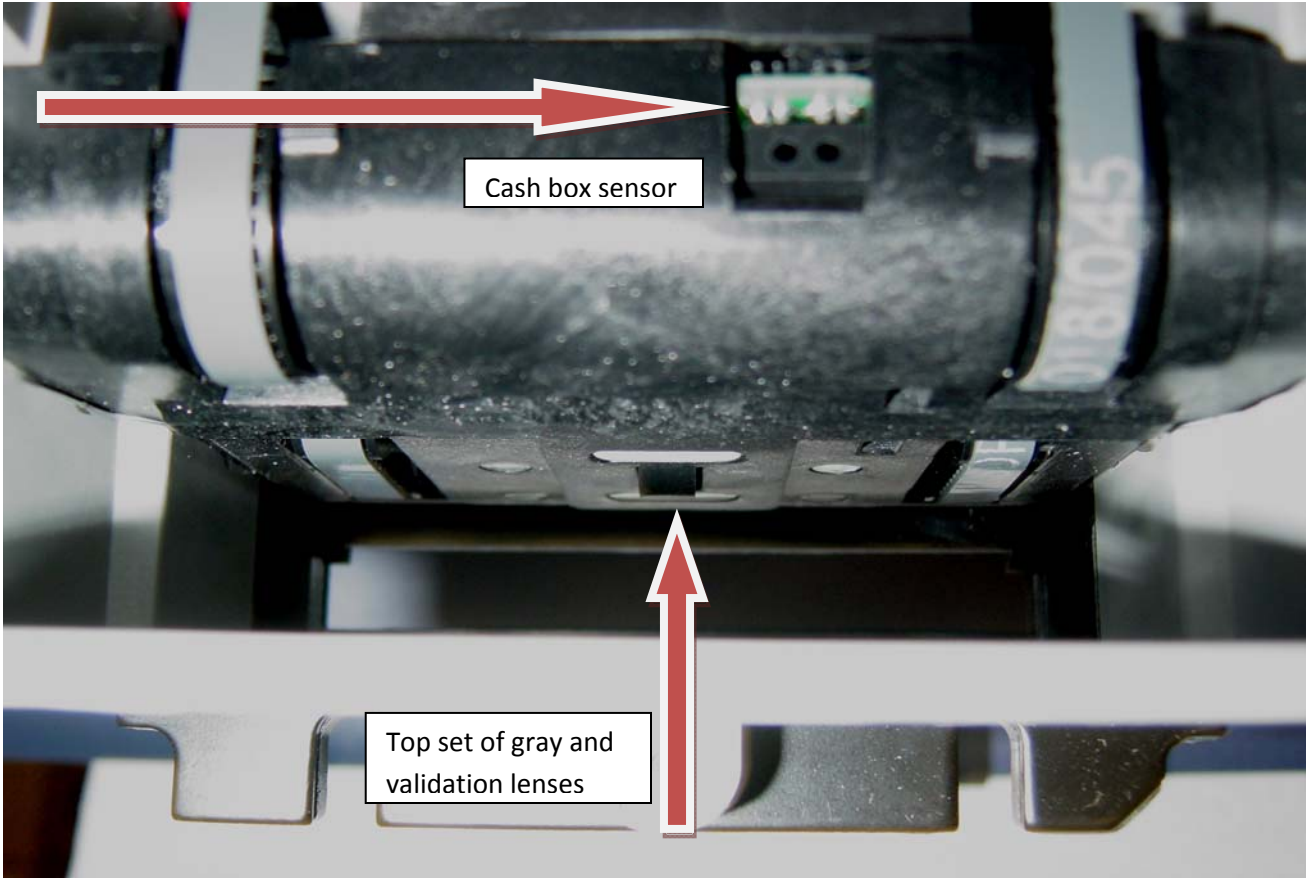
Directly above the plate inside the validator, there is another set of round and oval lenses that beam back and forth to each other in the bill path plate. Dampen a lint free cloth with water, only enough water to pick up dust and run the cloth over all lenses and rollers until clean.

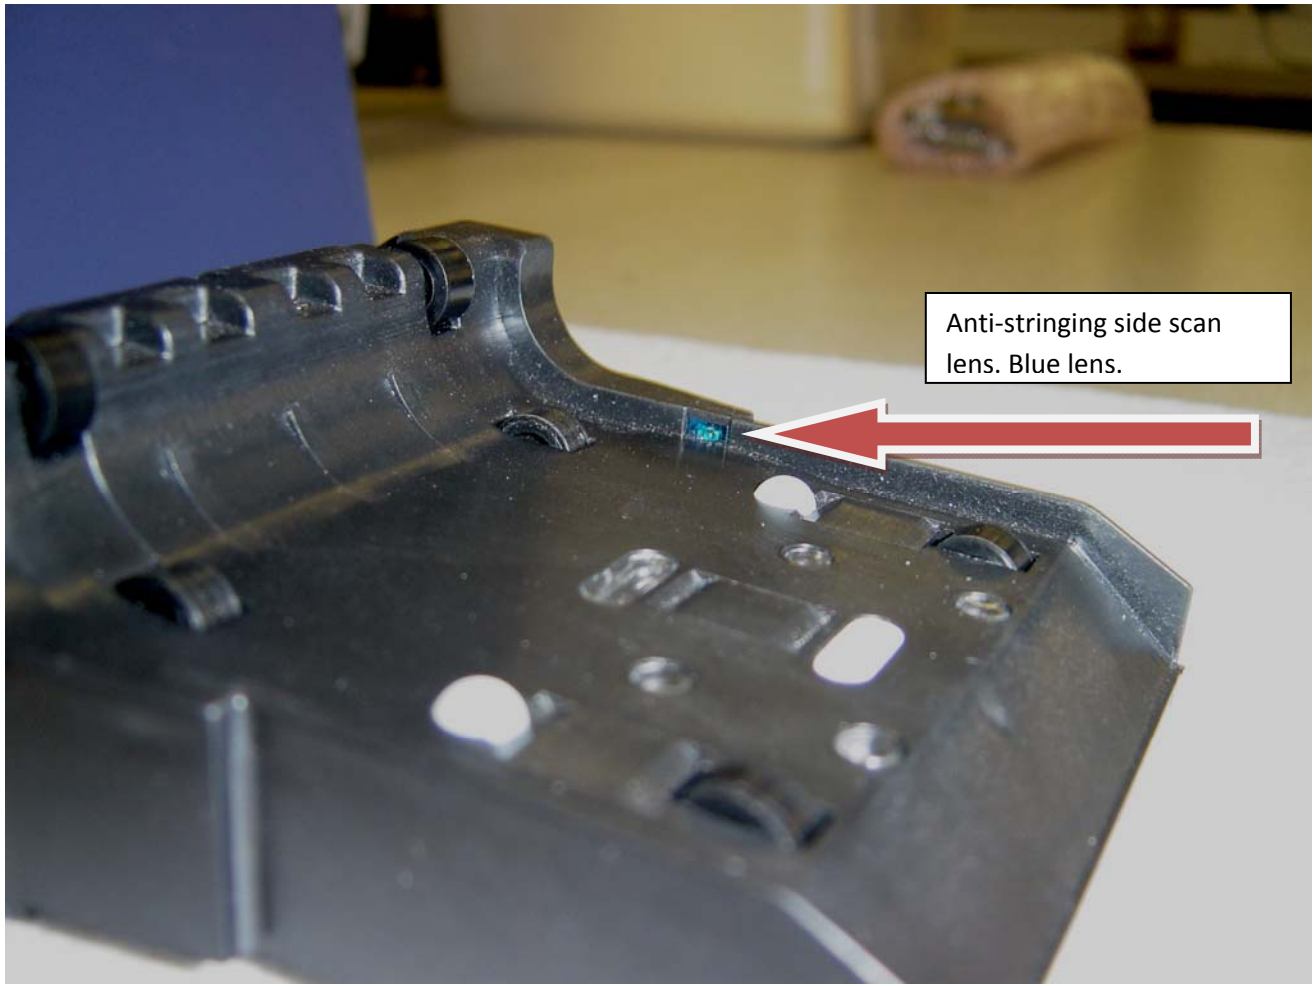
Anti-stringing side scan lens. Blue lens.

Use the pictures (more pictures below) to locate the side scan anti stringing, gray lenses and cash box sensor. Be sure to keep these lenses clean and debris free. If smoke or dirt builds up in these areas, bill acceptance and performance will lower and bill rejects will become more frequent. In certain cases water may not be enough to clean the surfaces. We recommend a 50% alcohol and water solution. This solution can also be used to clean the drive belts if they are extremely dirty. **NEVER USE OILS OR SILICON SPRAY ON THE ACCEPTOR**
